# Studies and Analysis of Effect of Foreign Particles on the Parts of Steam Turbine

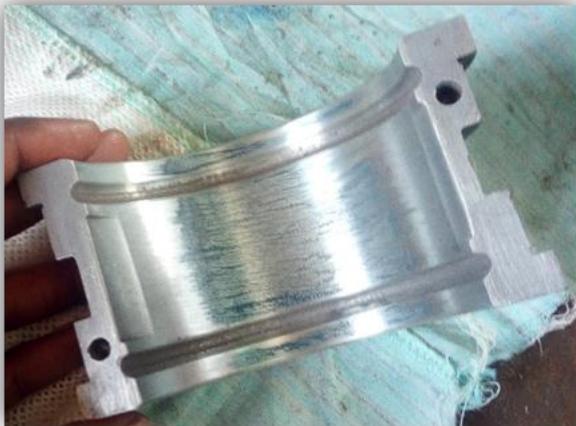
if lubrication oil pressure in bearing is not maintained between 1.5kg/cm<sup>2</sup> to 2 kg/cm<sup>2</sup>, the bearing is defected and the clearance between them increases. [4] Clearance between the rotor and bearing is adequate approximately 1 thou per one inch of the diameter of the rotor plus 0.003mm for lubrication oil. In the condition of increasing clearance, white metal casting is done on the bearing to decrease the clearance. Apply blue paste on rotor and take impression on bearing to match the face of bearing and rotor. Maintaining clearance of bearing by scrubbing of white metal with scrubber should be very careful. Even a single mistake damages the clearance of all over the bearing.

**Figure 1:** Bearing with blue paste impression

To maintain clearance, remove metal by scrubber very precisely. Marks of scrubber on bearing should not be acceptable. During witness marks, the metal should not be cut because it destroys the uniformity of face. Size of lead wire is used to check the clearance of the bearing, should be slightly greater than calculated clearance.

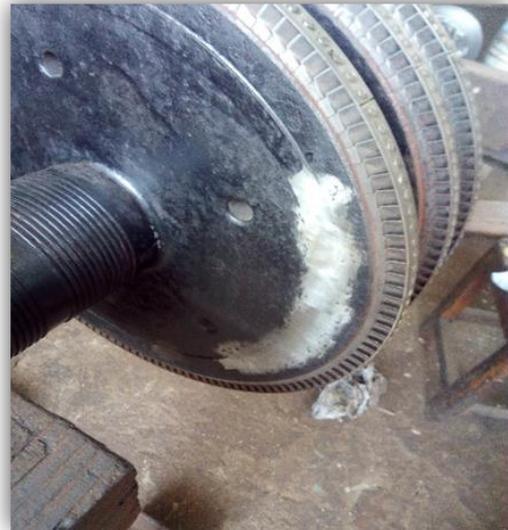
Vibration is occurred in the casing of turbine which is serious problem for turbine as well as operator's life. The vibration is occurred due to the sagging of the turbine. In this the rotor centre line is slightly buckled at the axis of the rotation of turbine rotor. Rotor balancing machine is used to identify the weight deflection of rotor, mark on rotor to machine the

**Figure 2 :** Metal removed to balance the rotor

portion of unbalance weight to balance the weight of rotor. Balance marking of unbalance portion of rotor is done properly. Deflection is occurred due to unbalance weight of rotor, should be removed. Metal should be removed very slowly by grinding because fast removing metal process may chance to over grinding the disc of rotor. Axial clearance and radial clearance of rotor and gear should be measured after assembly of bearing, because without bearing cover, the radial clearance should not have observed and observation of axial clearance should be greater than actual clearance. Tighten the studs and bolts properly for exact observation.

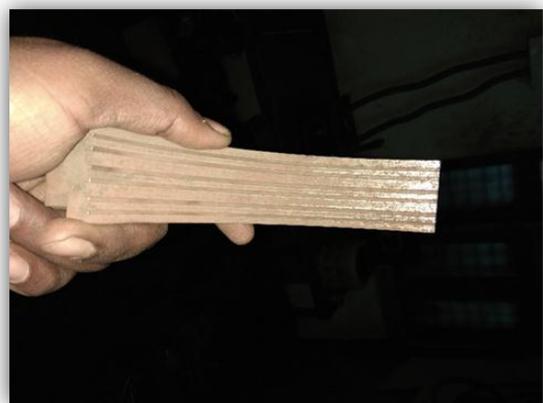
Leakage of steam is occurred due to rubbing of the teeth of the labyrinth strip to the rotor and clearance increases. Sometimes the clearance of the rotor and labyrinth increases due to loss of stiffness by the leaf spring of the labyrinth seal.

**Figure 3:** Rusted and defective labyrinth

After long interval of time the labyrinth strip becomes rusted. These rust and dust particle is removed with the help of emery paper. After polishing the labyrinth, it should not rub the

edges of strip very hardly with emery paper. It may increase the thickness of the labyrinth teeth which may rub and damage the smoothness of the rotor's shaft. So, the thickness of edges of the labyrinth should be very fine.

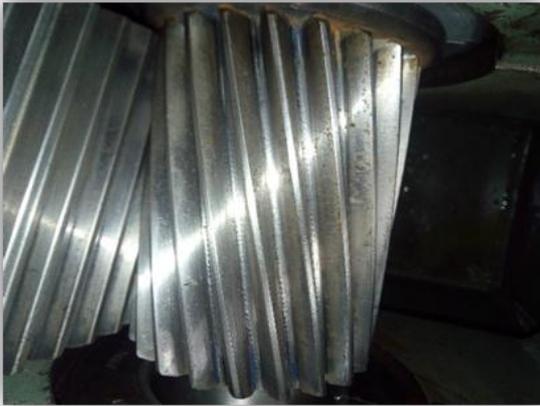
Gear box with turbine which is reduction gear of ratio 5.45: 1 to 5.50: 1. The main defect of the gear is backlash clearance, which increases due to the meshing of teeth of gear and pinion. These defects increase the noise in gear box and don't transfer the torque properly to the alternator.

**Figure 4 :** teeth with removed nickel coating on some portion of teeth

In this defect the teeth of the gear don't mesh with teeth of pinion properly. Then teeth are not completely meshed to each other and nickel coating of the gears are removed due to high load on small portion of the teeth which may arise the chances of breaking of the teeth. To prevent these types of defects, regular check the meshing of the teeth by taking blue paste impression. These defects decrease the life of the gear and increase the axial thrust and overhauled condition may arise. Complete gear box is change for proper operation which is very costly. Axial clearance should not exceed  $\pm 0.1\text{mm}$  and backlash clearance is not exceeding  $\pm 0.1\text{mm}$

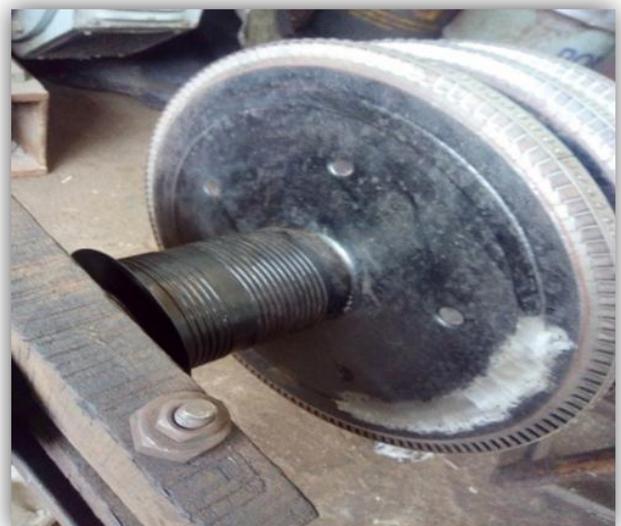
*Unbalancing of rotor*: -Mainly rotor is unbalanced when we stop the rotation of rotor at high temperature, due to this sagging occurs.

**Figure 5:** Rotor after balancing

Remedies: - Rotor should be balanced with the help of balancing machine. Rotor is subjected to nearly 20% overspeed test and is balanced at 5000 rpm. Mark the portion of rotor with chalk on disc which is machined to balance the rotor. Balance the rotor to every fine degree of precision. Machining of unbalance load on rotor is shown in fig-5.

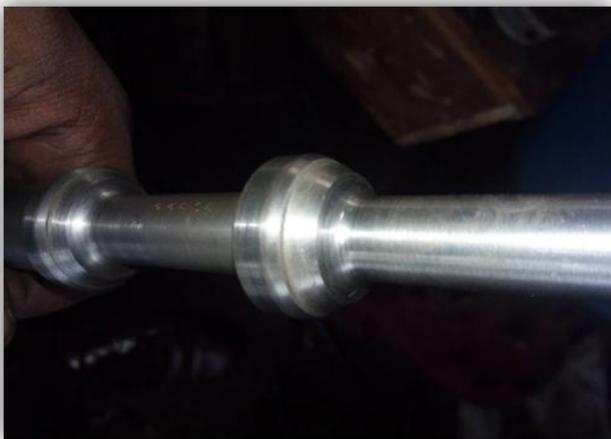
The seat of the valve gets scratched. Oil gets leaked even after fully closed. this defect makes difficult to rise the pressure of controlling oil. Due to this defect the load on oil pump increases. The defect mark is shown in fig-6.

This scratch is obtained due to dust particle get trapped between valve seat and housing. The dust particle may be iron pieces or babbitt material powder come with oil and they trapped between seat and housing, produce mark on valve seat. Due to improper working of oil filter, it is unable to filter dust particle.

**Figure 6:** Defect of OPCV seat defect mark

Apply the paste on scratched area and gently rubbing to remove the strain and surface scratched of the valve gets smooth by putting the valve in housing then rotate axially in clockwise and anticlockwise until the marks are removed. Now see carefully there should be no marks left. Then examine smoothness by penetration method (NDT method). After satisfactory result apply blue past and taking impression

in housing. if impression is obtained proper on all around the seat then it should be fine that seat is ready to use with its proper function. If these scratches is more deep then seat is required to be changed

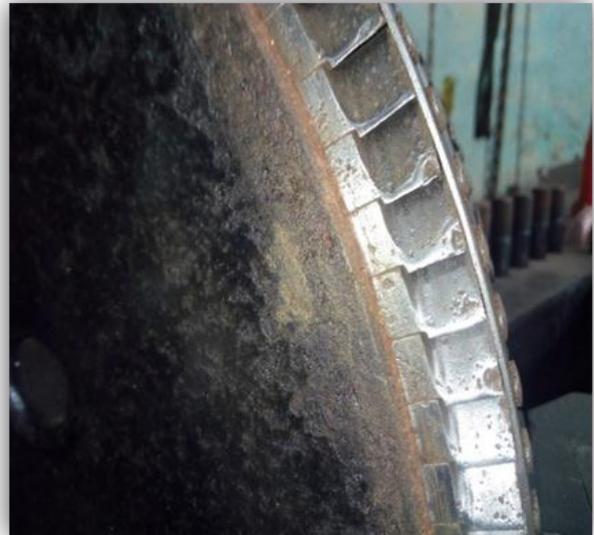
In old turbines the edge of the blade of rotor is eroded and nozzles attack trailing edges. Edges chipped off and erosion blow holes are occurred, deep dent marks are occurred due to impact of foreign particle as shown in fig-7. Impact on blade and nozzle of turbine get some particles eroded from blades. solid particle is generally iron from steam line and super heater of boiler. These particles get strikes on the blades and get eroded. The effect of poor quality steam is considerable, that dissolves salt of boiler heater. These salts come with superheated steam and sticks to the blades. Generally, solid gets deposited on the blades and results in decrease of the steam flow area due to reduction in the flow area. Therefore, the stage pressure increases in turbines, axial thrust increases and turbine is unable to wear desired load on the basis of steam consumption. The Increase in axial thrust and tripping is occurred via thrust wear trip.

**Figure 7:** Show the pitting on blades of rotor

The gap between nozzle and blade gets increase, then more steam is required to operate the turbine at same load as the designing of turbine. Thus, increases steam consumption and the temperature of the exhaust steam increases. Then estimated design which leads to the many defect such as bearing high temp trip and many other.

Replace the defected blade with new blade with the dimension according to the manual of turbine with better composition of material.

Properly treated water should be used in boiler for making steam.

Balancing the pH of feed water according to the requirement of the turbine.

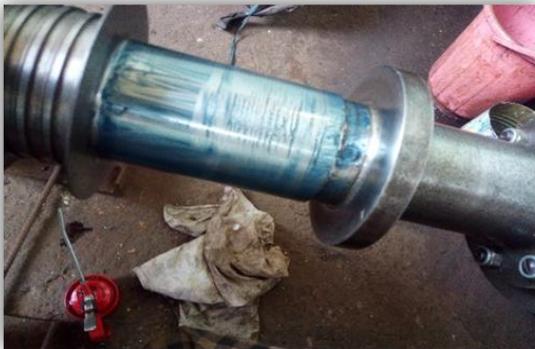
**Figure 8:** Bearing impression on rotor

Defects: - The main defect in the bearing is to increase the clearance of bearing due to degradation of white metal. Witness marks disappeared and scratches are appearing on bearing.

Causes: - The increment in clearance of the turbine bearing is due to sudden great fluctuation in RPM of turbine rotor. Poor filtration of controlling oil and lubricating oil contained particle of metal. Due to this particle Scratches and marks are appeared. Another reason of bearing damage is low oil pressure of lubricating oil in bearing, which is insufficient to make film.

Remedies: -The material used for rebabbiting is pure the old bearing babbitt material is not mix with new one because very seldom will someone know the exact composition of their old babbitt, much less if it is even a tin based or lead based product. Because mixing these two causes the low melting 63Sn/37Pb eutectic to be formed. The 63/37 melts at 3610F and Grade-B babbitt does not completely melt until 6690F. A premature bearing failure is the result. If babbitt is known tin based babbitt, no more than 30% of pour should be recycled alloy [11].

To remove defects is to change the bearing if white metal is degraded more. Don't run the turbine before lubricant oil pressure is maintained in range of 1.5 to 2 kg/cm<sup>2</sup>. Oil pressure is slightly different with turbine of different companies as per their design on same load. proper check the bearing vibration, lube oil pressure and temperature with help of RTD. Deposit the babbitt metal on bearing and apply blue paste on rotor and take blue paste impression on the bearing as shown in fig-8 and fig-9. Match the face of bearing with rotor to examine the formation of uniform thickness of the oil film in bearing during rotation on high speed. Maintain the clearance between the rotor and bearing in the range of 0.25 to 0.35.

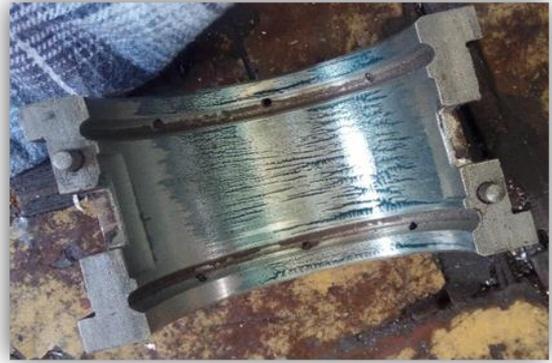
**Figure 9:-** bearing with blue paste impression shows non-uniform messing with rotor

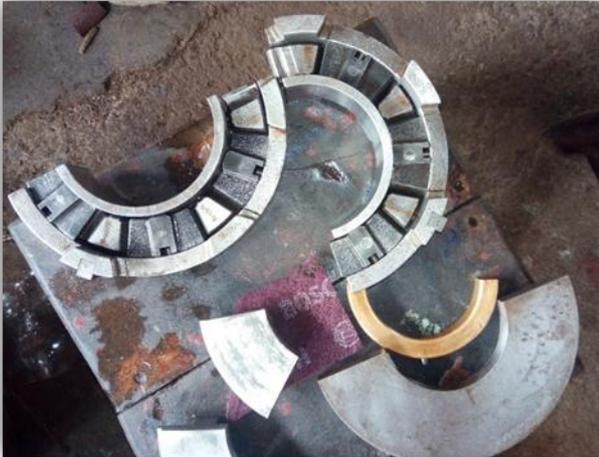
**Figure 11:** - Thrust pad

Defect in thrust pad: - Only and only one defect in thrust pad is due to removal of the white metal due to the axial movement. This white metal transfers the momentum of the rotor to the pad and prevents the turbine gear.

This is due to condensate water carried with steam and impact on blade occurs due to its weight, which result in axial movement of the rotor, which hits the thrust pad, due to increment in axial clearance of shaft.

Deposition of white metal on defective pad is cheaper solution than replacing the pad.

Check the axial clearance of the shaft. Compare its design and correct them according to their recommended manual of turbine.

Change the defective pad or deposit the metal in foundry shop and measure thickness of the pad. Tolerance of 0.0130mm is allowed.

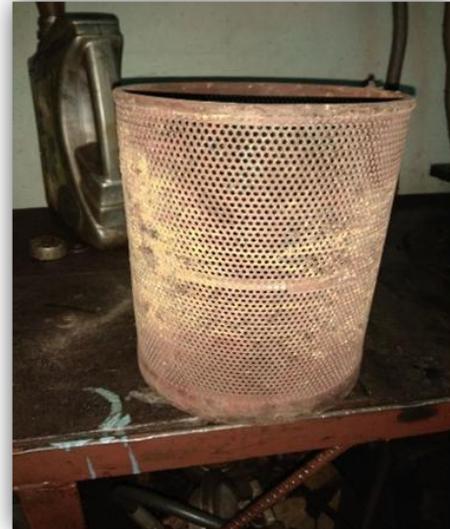
The cylindrical shape strainer has holes to filter steam and stop debris material to enter in the turbine casing. These holes get clogged due to rusting because turbine is in stationary condition for long interval of time. These holes are clogged with scale, rust, dust particle as shown in fig-12.

**Figure 12:** - clogged holes of strainer

Strainer should be rupture and debris enter in turbine and may damage in valve seat, blade, nozzle with distortions consequences. Water slug in undrained line is liable to impose serious shock on the turbine. These shock load may result in heavy vibration, uncontrolled speed fluctuation, overspeed occurs and load on the trust pad increases and chances of failure of pad are more.

Open the clogged holes by using the compressed air at high pressure.

Clean the strainer properly.

Open the clogged holes, change the strainer if the thickness of the strainer is reduced considerably.

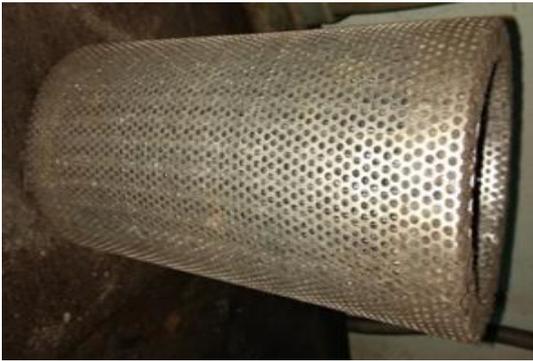
**Figure 13:** - clogged holes of oil filter

Defects: - Pores of filter is clogged due to dust particle of the oil. Use the sponge for cleaning including tank of oil. Instead of rags cloth waste or any fibrous material.

Switch their oil filter and clean plugged side.

Replace filter element when blockage indicator shows red.

Change the filter after 2000 hrs of working.

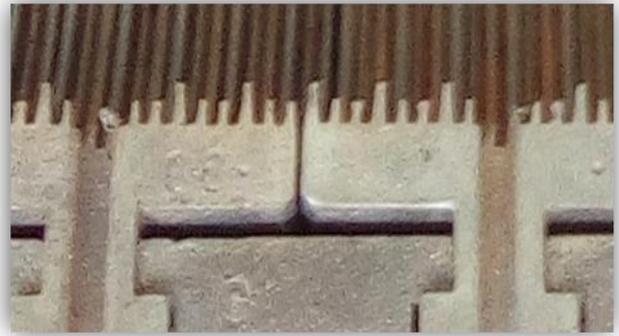
**Figure 15:** - Damage teeth

Defects: -Increasing clearance between labyrinth and rotor more than 0.45. The labyrinth strips are rubbed and decreased due to friction between teeth and rotor. The teeth are bent and broken. Sometimes these strips are swallow due to sudden very high temp of steam and stick to the rotor. labyrinth is damaged as shown in fig-15.

Remedies: -Remove scale deposits on the spring and check its stiffness and elasticity property. If the leaf spring of labyrinth lose its elasticity then changes the spring with adequate spring stiffness. Maintain the clearance between strip and rotor between 0.30mm to 0.45mm. Change the labyrinth strip in case of strip damages.

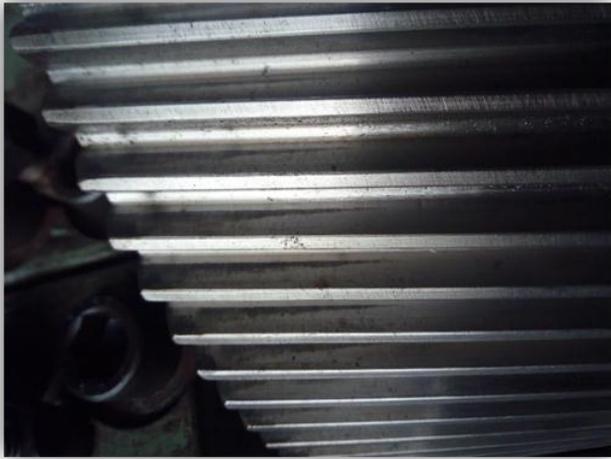
Gear box of turbine which is reduction gear of ratio 5.45: 1 to 5.50: 1. The main defect of the gear is backlash clearance, which is increases due to the meshing of teeth of gear and pinion these defects increase the noise in gear box and don't transfer the torque to the alternator properly.

**Figure 17:-**Teeth with removed nickel coating on some portion of teeth

Axial clearance should not exceed  $\pm 0.1\text{mm}$  and backlash clearance is not exceeding  $\pm 0.1\text{mm}$ . In this defect the teeth of the gear don't mesh with teeth of pinion properly. It means that teeth don't completely mesh with each other and nickel coating of the gears are removed due to high load on small portion of the teeth which may arise the chances of broking of the teeth. To prevent these types of defect regular check the meshing of the teeth by taking blue paste impression. These defects decrease the life of the gear and increase the axial thrust and overhauled condition may arise. Complete gear box is changed for proper operation, which is very costly.
