# Studies and Analysis of Effect of Foreign Particles on the Parts of Steam Turbine

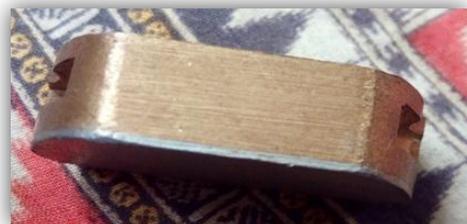
**Figure 10:-**Thickness of white metal

These pads are coated with white metal. The number of active pad and non-active pad are equal on both side. These pads are designed to transfer the high axial load of shaft instant of rotation of shaft.

Defect in thrust pad: - Only and only one defect in thrust pad is due to removal of the white metal due to the axial movement. This white metal transfers the momentum of the rotor to the pad and prevents the turbine gear.

Deposition of white metal on defective pad is cheaper solution than replacing the pad.

Check the axial clearance of the shaft. Compare its design and correct them according to their recommended manual of turbine.

Change the defective pad or deposit the metal in foundry shop and measure thickness of the pad. Tolerance of 0.0130mm is allowed.

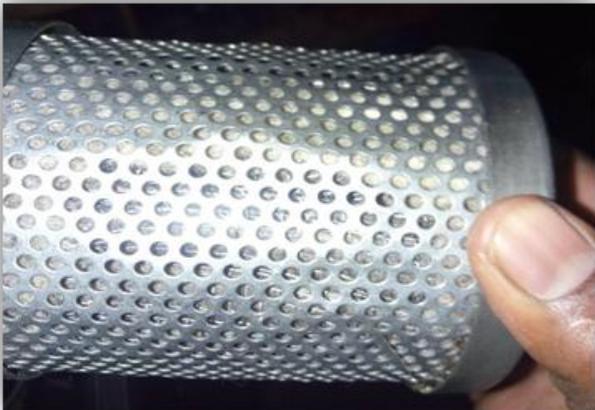
**Figure 14:-** oil filter after removing dust

Defects: - Pores of filter is clogged due to dust particle of the oil. Use the sponge for cleaning including tank of oil. Instead of rags cloth waste or any fibrous material.

Replace filter element when blockage indicator shows red.

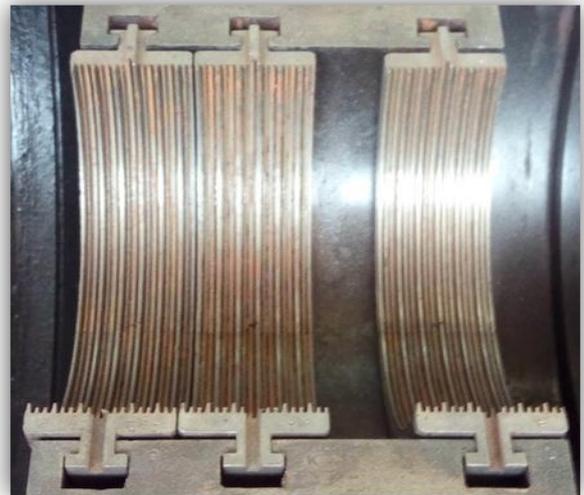
**Figure 16:** Labyrinth gland

Defects: -Increasing clearance between labyrinth and rotor more than 0.45. The labyrinth strips are rubbed and decreased due to friction between teeth and rotor. The teeth are bent and broken. Sometimes these strips are swallow due to sudden very high temp of steam and stick to the rotor. labyrinth is damaged as shown in fig-15.

Remedies: -Remove scale deposits on the spring and check its stiffness and elasticity property. If the leaf spring of labyrinth lose its elasticity then changes the spring with adequate spring stiffness. Maintain the clearance between strip and rotor between 0.30mm to 0.45mm. Change the labyrinth strip in case of strip damages.
